EXAMPLE BUYING ASSESSMENT

Illustrative assessment only; not advice about an actual vehicle

### 2020 Example Motors Demo Sedan Example

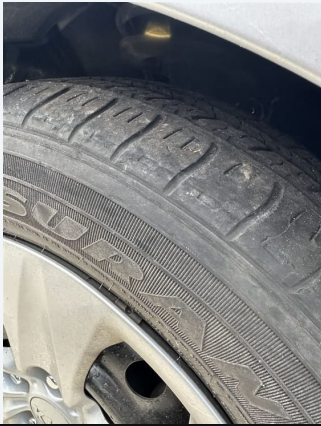
PHOTO 01 - Illustrative tire wear (#155)

Example uneven left-front wear. Check alignment and suspension, then plan tire service. Photo 01 is an illustrative wear example, not this vehicle.

| # | CHECK | METHOD | RESULT / NOTE |
|---|---|---|---|
| 155 | Left-front wear pattern | VISUAL | MONITOR - Example uneven left-front wear. Check alignment and suspension, then plan tire service. Photo 01 is an illustrative wear example, not this vehicle. |

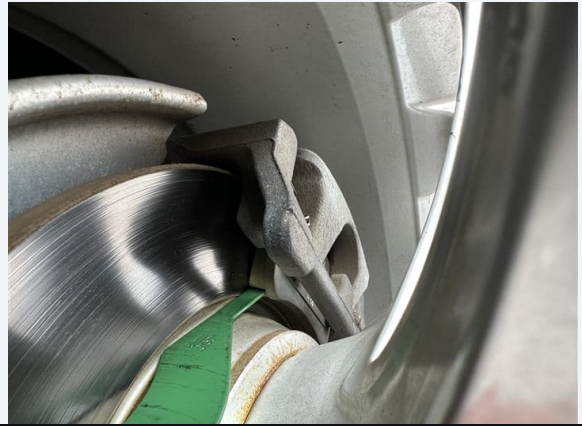
PHOTO 02 - Illustrative brake check (#137)

Example front pads measure 4 mm. Plan brake service and confirm rotor condition with the repair facility. Photo 02 illustrates the inspection area, not these measurements.

| # | CHECK | METHOD | RESULT / NOTE |
|---|---|---|---|
| 137 | Front brake-pad thickness | MEASUREMENT | MONITOR - Example front pads measure 4 mm. Plan brake service and confirm rotor condition with the repair facility. Photo 02 illustrates the inspection area, not these measurements. |

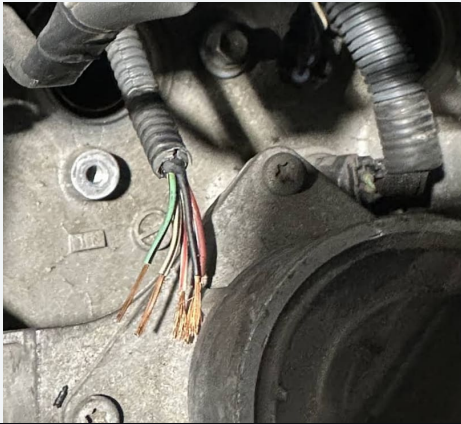
PHOTO 03 - Illustrative wiring concern (#91)

Example finding: damaged insulation at a visible engine connector. Have the circuit diagnosed and wiring repaired before purchase. Photo 03 is illustrative, not evidence from this vehicle.

| # | CHECK | METHOD | RESULT / NOTE |
|---|---|---|---|
| 91 | Engine-bay wiring and connectors | VISUAL | CONCERN - Example finding: damaged insulation at a visible engine connector. Have the circuit diagnosed and wiring repaired before purchase. Photo 03 is illustrative, not evidence from this vehicle. |
